NIST NCSTAR 2: Vol. I

Report of the Technical Investigation of The Station Nightclub Fire

June 2005

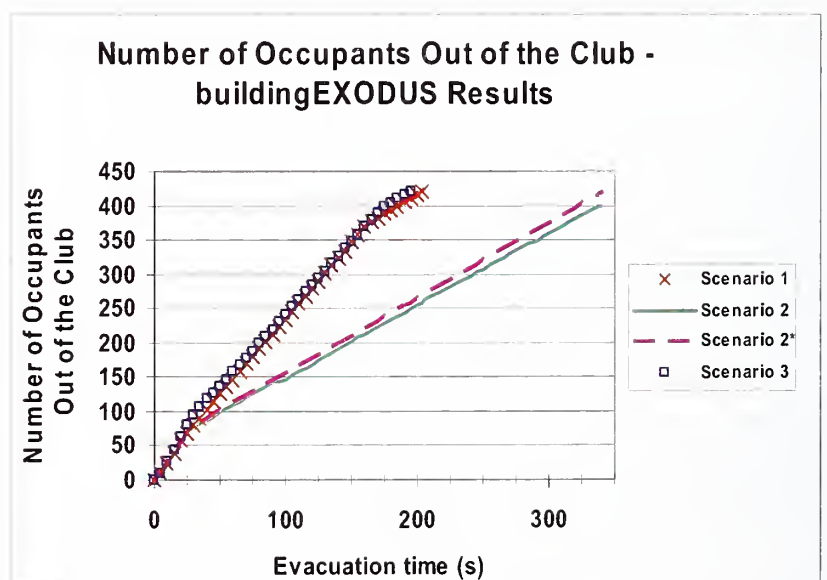
The inability of the exits to handle all of the occupants in the short time available for this fast growing fire contributed directly to the large loss of life. The number of building occupants at the time of the fire was reported by the news media to range from 440 to 458; the occupant limit for a building similar to The Station nightclub would be around 420 persons according to the 2003 model codes. Three emergency exits were available: the front main entrance on the north (limited by the single door into the vestibule), the single door on the west near the performance platform, and the single door on the east side of the main bar. A fourth door in the kitchen was not considered accessible to the patrons. The first patrons recognized the fire danger about 24 seconds after ignition of the foam; the bulk of the crowd began to evacuate shortly after that, around the time the band stopped playing (30 seconds). The rate of egress from the main entrance at the front of the building was limited initially by the single doorway inside the vestibule, not the double doors visible from the outside. From 56 percent to 66 percent of the occupants appear to have attempted to leave through the single main entrance in the front of the building; many were unsuccessful. The windows in the main bar room and the sunroom became the secondary routes of escape once the main entrance became impassable, and, according to reports, they accounted for over 1/3 of the successful evacuations.

Prior to 1-1/2 minutes into the fire, a crowd-crush occurred in the front vestibule which almost entirely disrupted the flow through the main exit. Many people became stuck in the prone position in the exterior double doors.

Simulation of egress for different scenarios

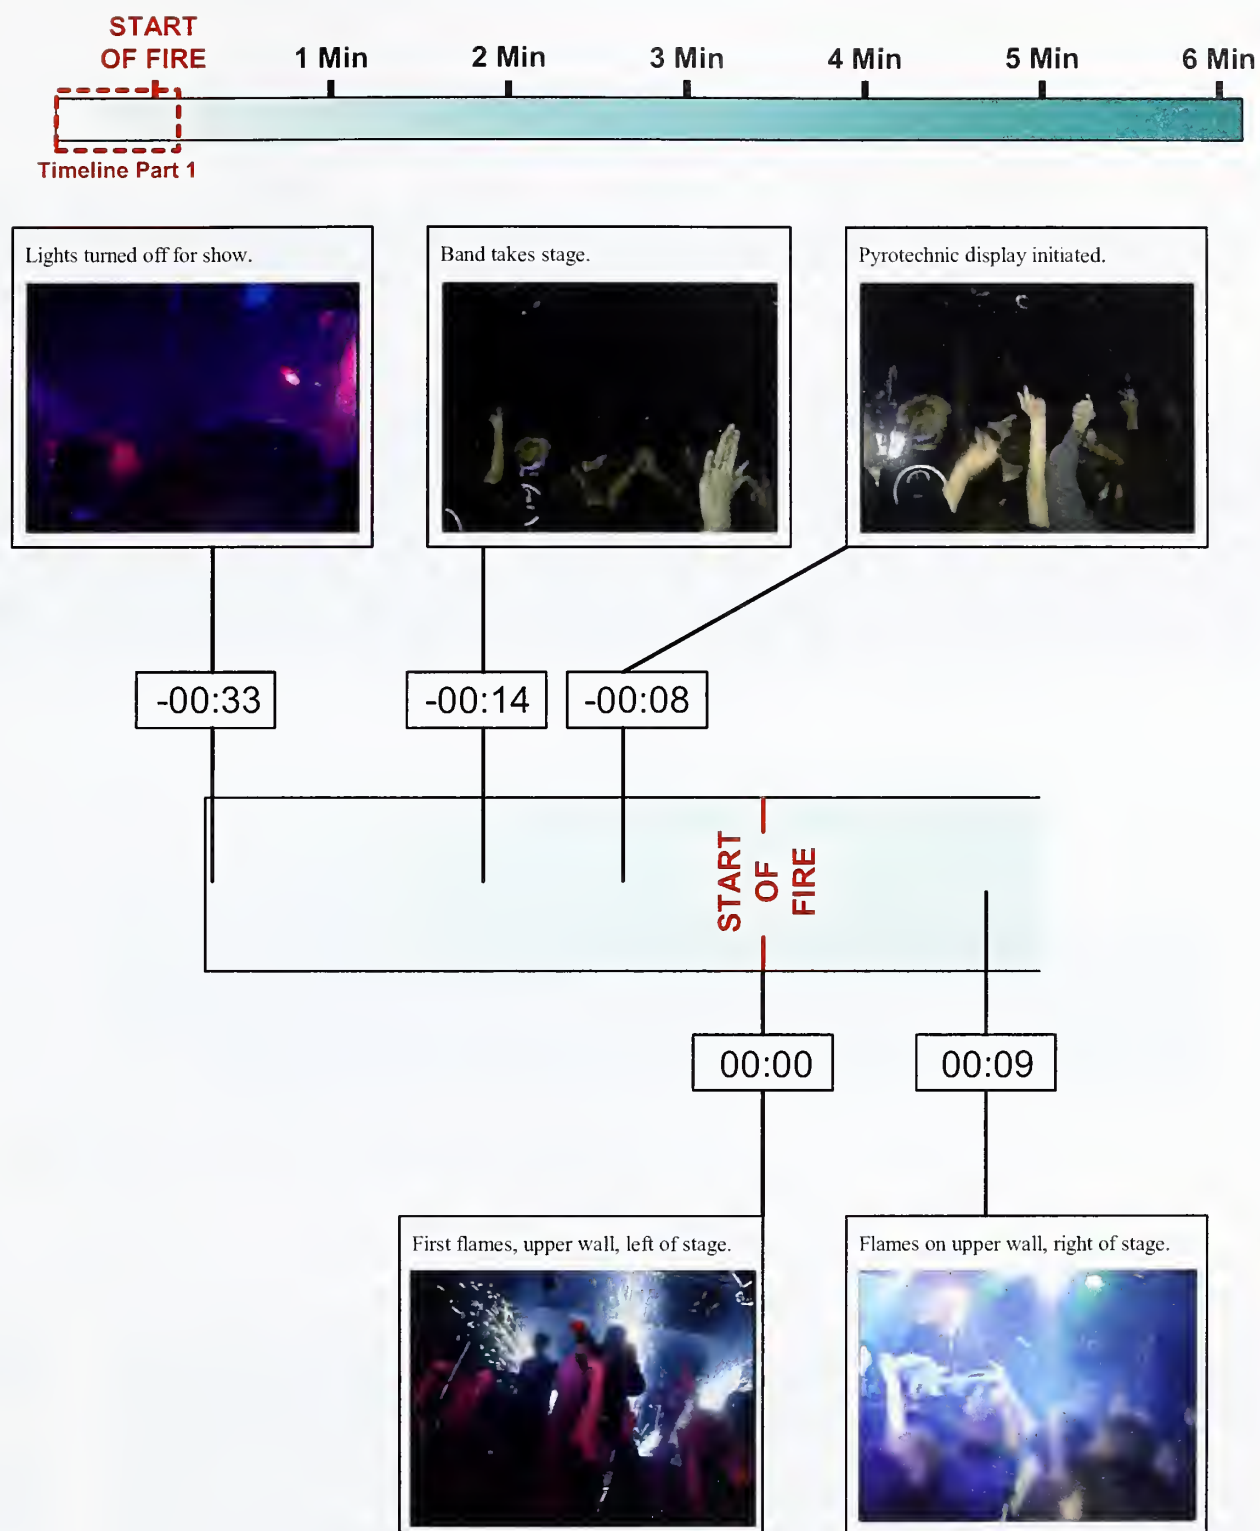
The timeline that resulted from this analysis, with reference to the still frames from which events were identified (refer to Appendix A for images), is provided in Figures 2-2a through 2-2d. The timeline indicates times in relation to the initiation of fire on the platform, estimated to occur at 11:08:01 pm EST (06:22 video time).

Figure 2-2a. Evacuation Timeline (33 seconds before to 10 seconds after ignition). Video stills copyright © 2003 TVL Broadcasting, Inc. All rights reserved.

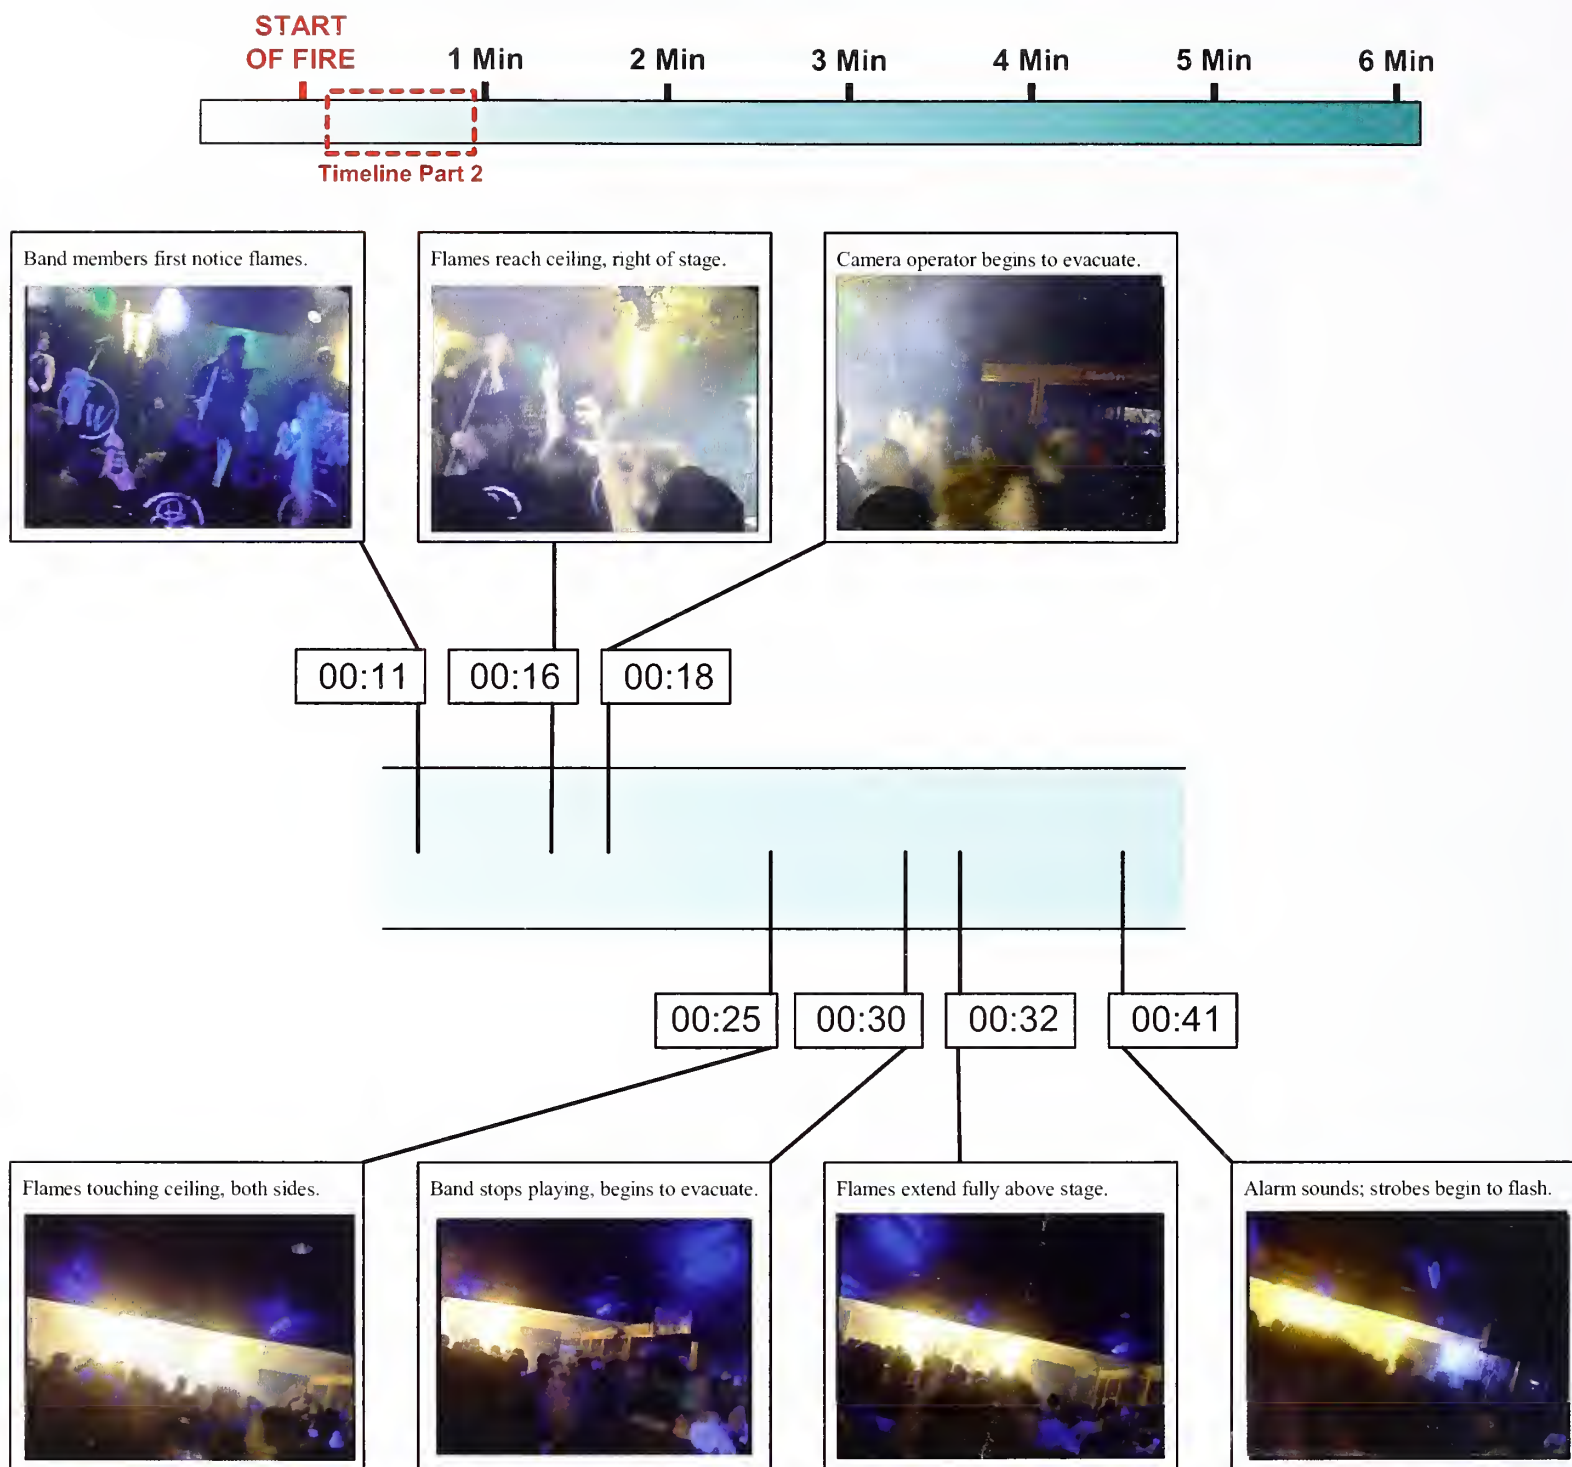
Figure 2-2b. Evacuation Timeline (10 seconds to 50 seconds after ignition). Video stills copyright © 2003 TVL Broadcasting, Inc. All rights reserved.

recognize the fire danger at 24 seconds. Around the time the band stopped playing (30 seconds fire time), the bulk of the crowd had begun the evacuation process. At 41 seconds the fire alarm could be heard and the strobe seen on the video. (See Fig. 2-2b.)

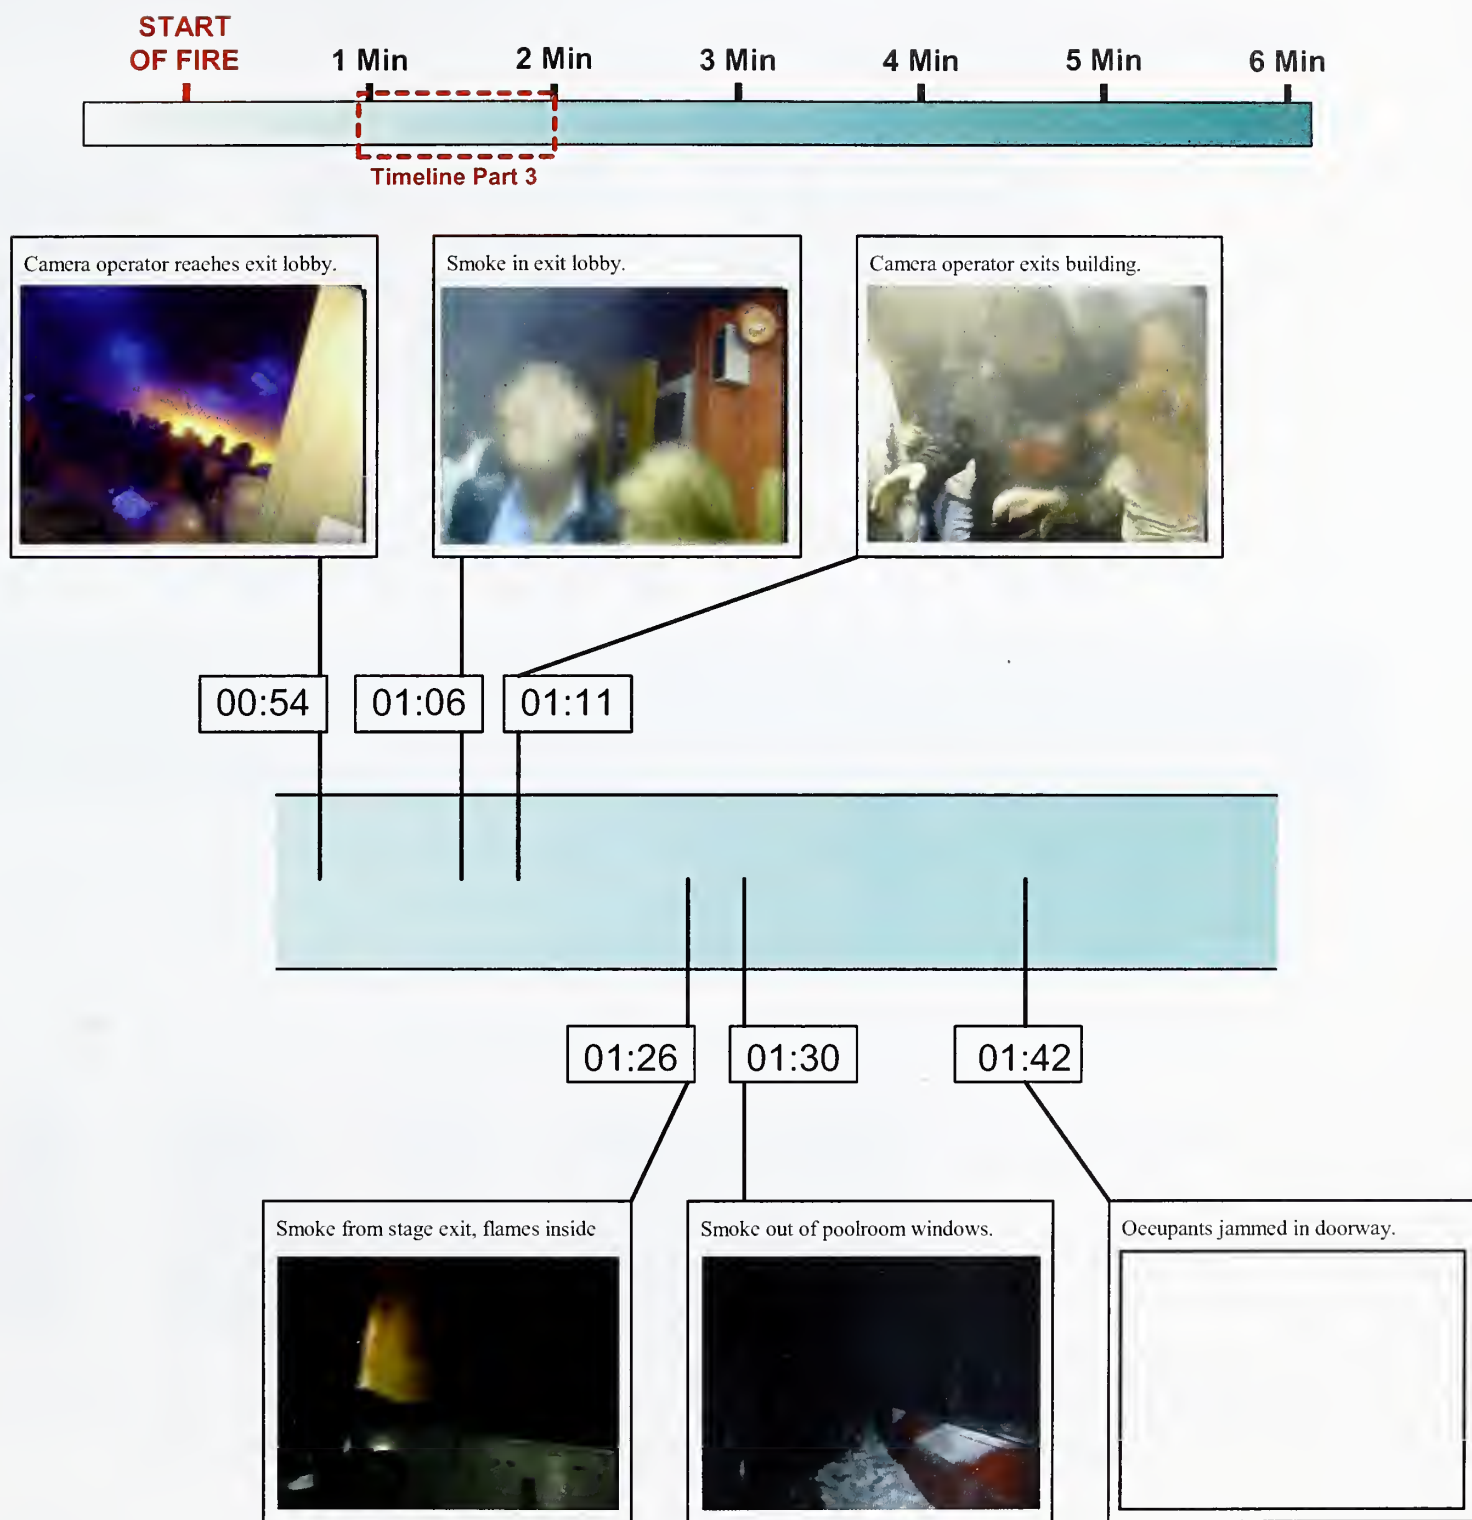
Figure 2-2c. Incident Timeline (50 seconds to 2 minutes after ignition). Video stills copyright © 2003 TVL Broadcasting, Inc. All rights reserved.

The videographer made his way to the exit lobby while continuing to capture the movement of the crowd leaving the area around the dance floor. As seen in Fig. 2-2c, he exited the building at 1 minute 11 seconds (fire time) along with a steady stream of occupants. Sometime estimated to be around 1 minute 30 seconds after ignition of the foam, the front exit became blocked with people, and occupants could be seen breaking windows and escaping from the poolroom/sunroom. The result of the crowd crush at the front exit was captured on the video at 1 minute 42 seconds (Fig. 2-2c). The latest time recorded for an occupant escaping from inside the main bar (through a window) was at 4 minutes 8 seconds; however, people stuck in the front entrance are seen in the video to have escaped as late as 5-1/2 minutes into the fire, just before the fire department ran its first hose line (Fig. 2-2d). (One patron claimed to have been pulled from the bottom of the pile by a firefighter considerably later, but this has not been confirmed by the NIST investigation.)

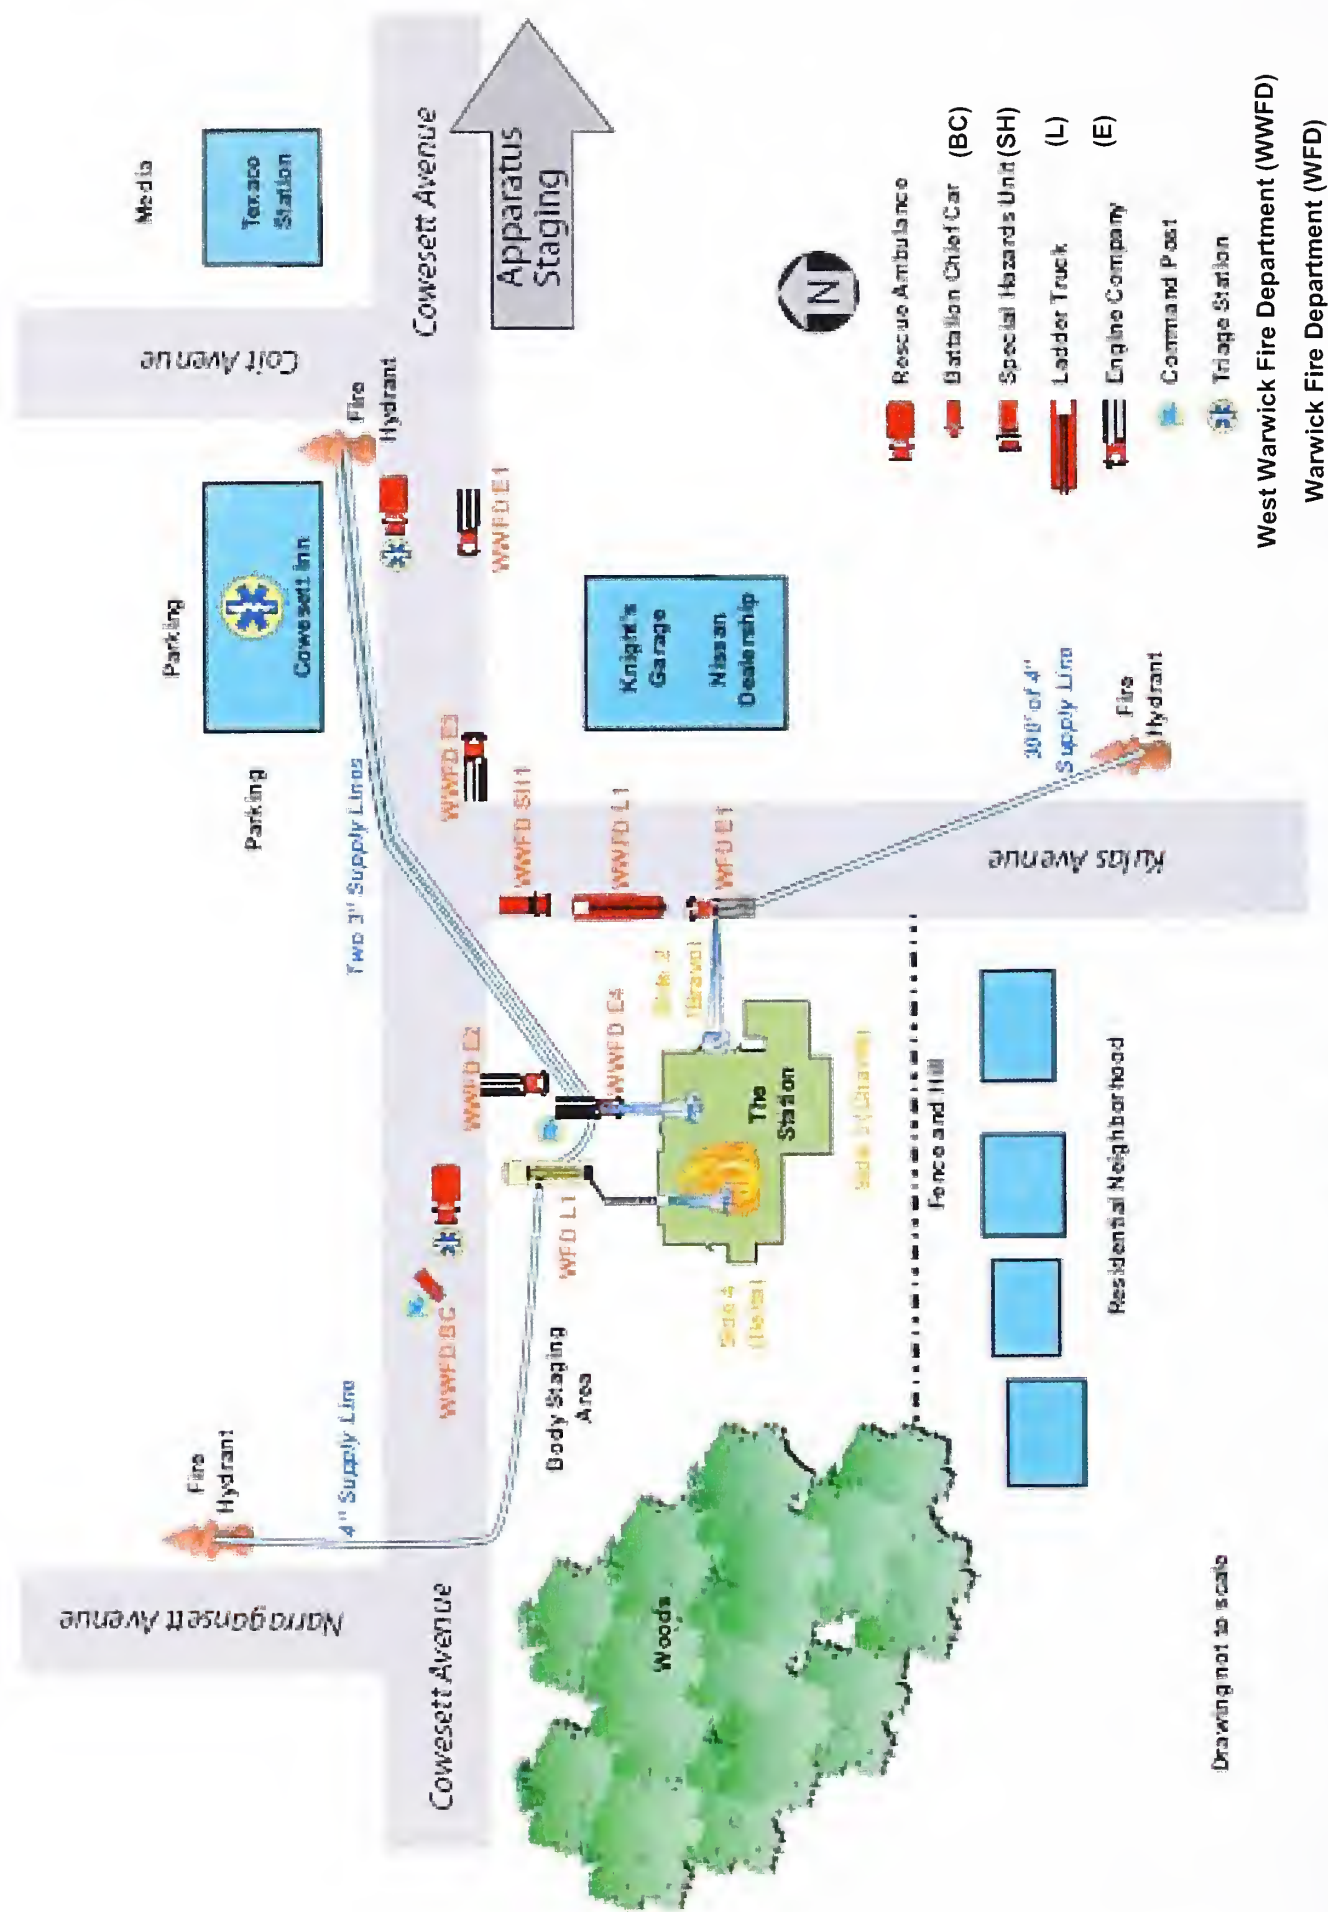
Figure 3-1. Schematic of primary apparatus deployment

The incident area had immediate access to a municipal hydrant system to support fire ground operations. Although positioned short distances away (see Figure 3-1), the incident site had expedient access to three hydrants, all of which were utilized.

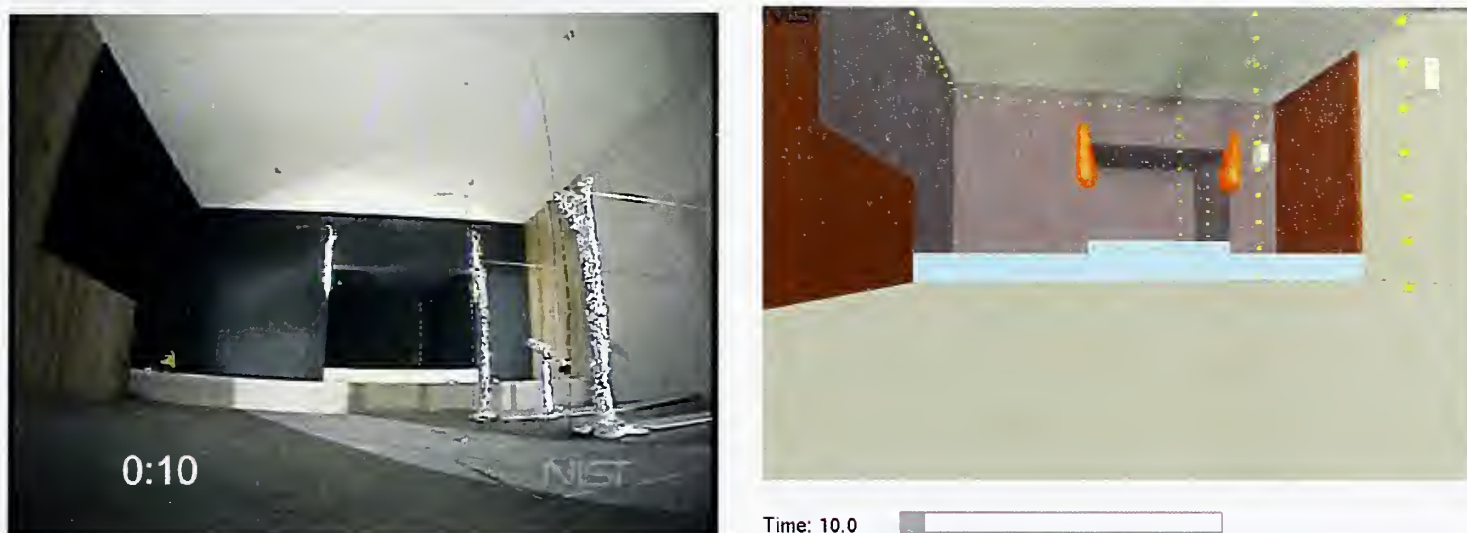
Figure 5-3. Flames spreading toward ceiling, $t = 10$ seconds after ignition.

Figure 5-3 compares the fire development at 10 seconds after ignition. A flame is shown on both corners where the platform wall intersects with the drummer's alcove. In the case of FDS, the area that appears to be involved with flames is based on the stoichiometric mixture fraction, where there is the ideal mixture of fuel and oxygen for a robust flame to exist. The heat release rate per unit volume represented by the simulated flames is 285.5 kW/m^3 . The flames in the simulation appear wider due to the grid resolution, which is 100 mm (4 in) throughout the room.

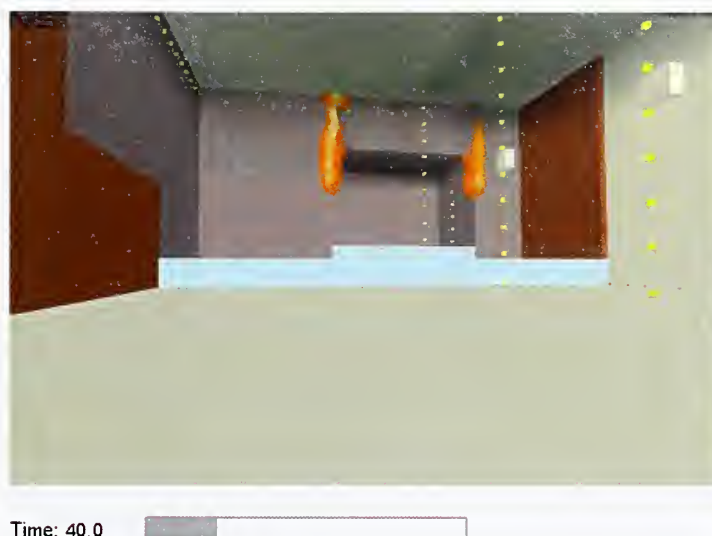
Figure 5-6. Flames continue to spread into alcove, $t = 40$ seconds after ignition.

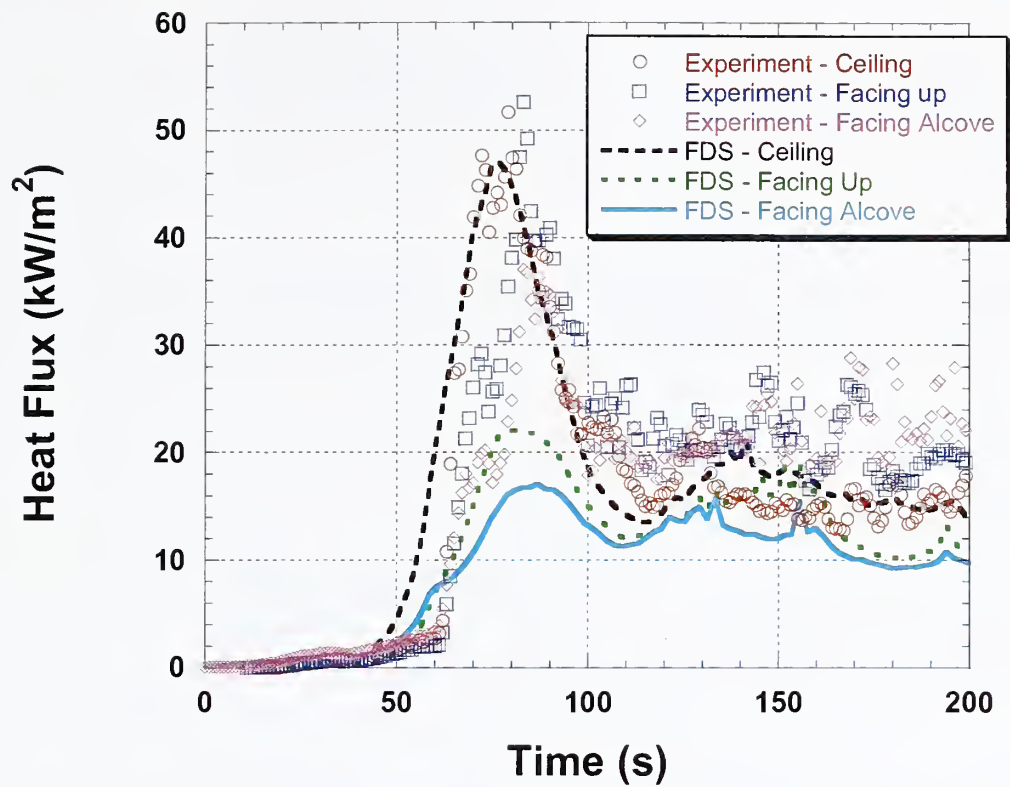
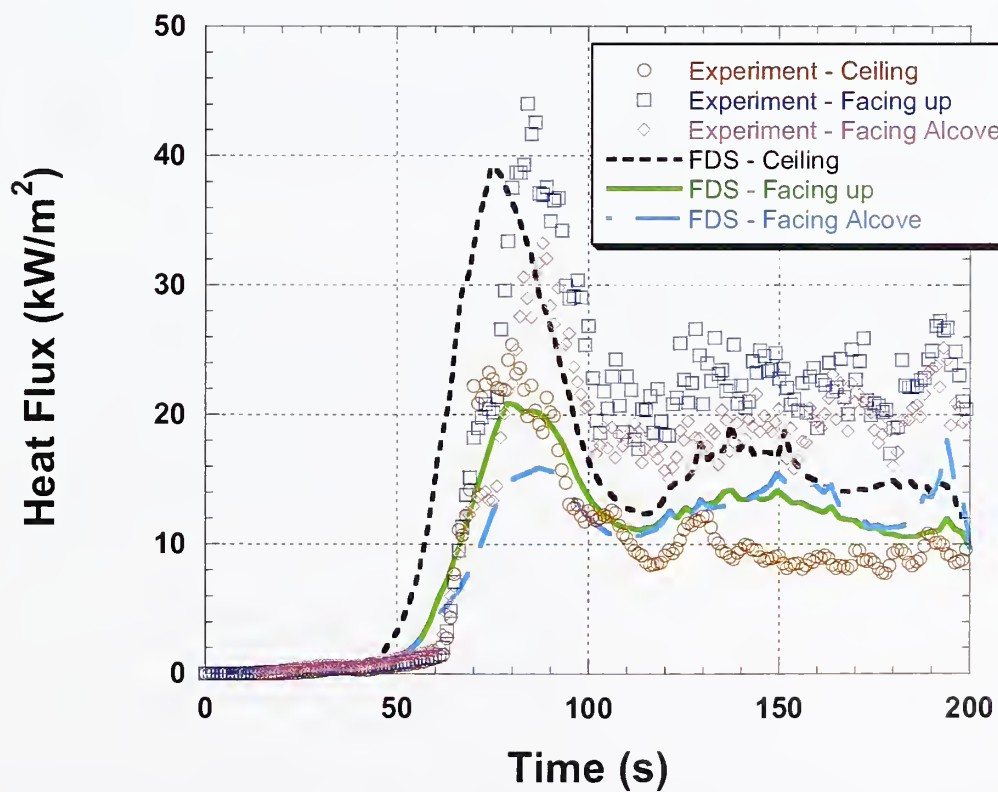
Figures 5-15 and 5-16 present the heat flux measurements taken at Stations C and D respectively. There were three total heat flux sensors at each position: one installed at ceiling level with the sensor aimed at the floor; and two sensors installed at approximately 1.5 m (5 ft) above the floor with one aimed at the ceiling and the other aimed toward the platform end of the enclosure. In both cases, the predictions follow the trends of the measured heat flux. Better agreement in terms of magnitude occurs at the ceiling level. The predicted heat fluxes 1.5 m above the floor are low by almost 50 % when compared with three out of four measurements.

Figure 5-15. Heat flux comparison between the un-sprinklered fire experiment and the FDS simulation at Station C

Figure 5-16. Heat flux comparison between the un-sprinklered fire experiment and the FDS simulation at Station D.

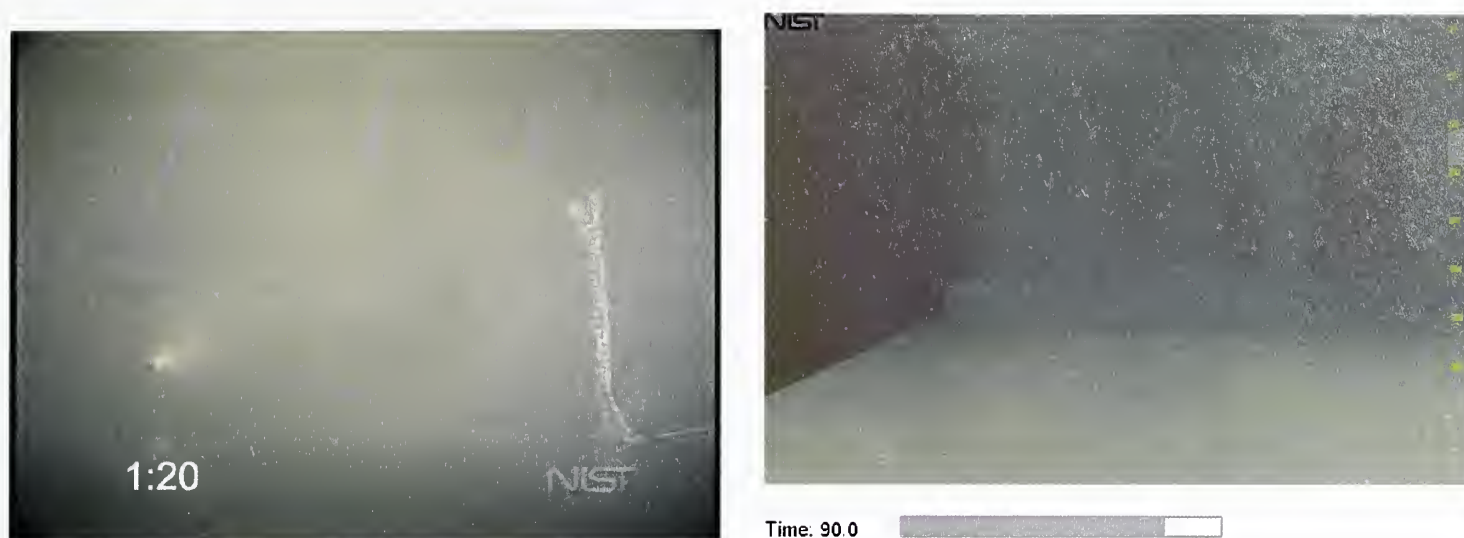
Figure 5-25. Fire suppression continues in both the experiment and the simulation, $t = 50$ seconds after ignition.

Figure 5-26. Fire controlled in both cases, $t = 60$ seconds after ignition.

Figure 5-27. Fire controlled in both cases, $t = 90$ seconds after ignition.

Figures 5-25 through 5-27 show continued fire suppression for both the experiment and the simulation. In both cases some flames exist in the ceiling area of the alcove. But clearly the rate of fire growth and the resulting hazard development has been reduced significantly when compared with the unsprinklered case.

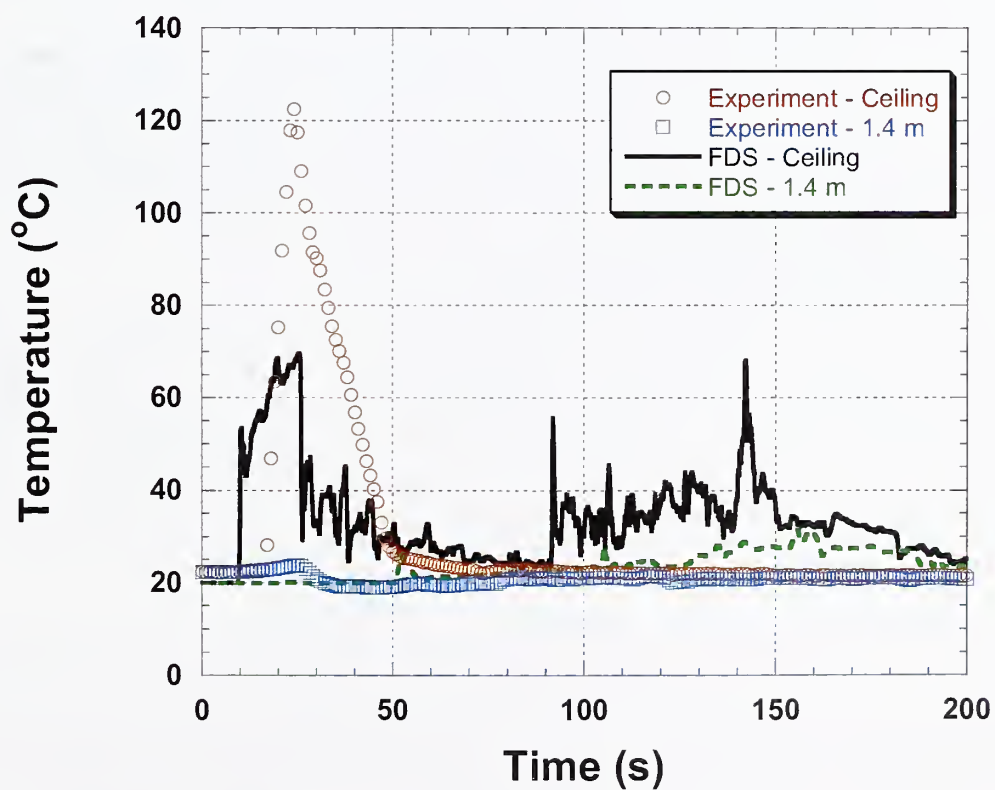
The comparison of the temperatures at Stations C and D are shown in Figures 5-29 and 5-30. In both cases FDS under predicts the temperatures near the ceiling. The FDS predictions in these two graphs have not been smoothed in order to show that the peak values near the ceiling are very close to the sprinkler activation temperature of 74 °C. Typically the temperature of the fire gases surrounding a sprinkler at the time of activation is approximately twice the listed temperature.

Figure 5-30. Temperature comparison between the sprinklered fire experiment and the FDS simulation at Station D.

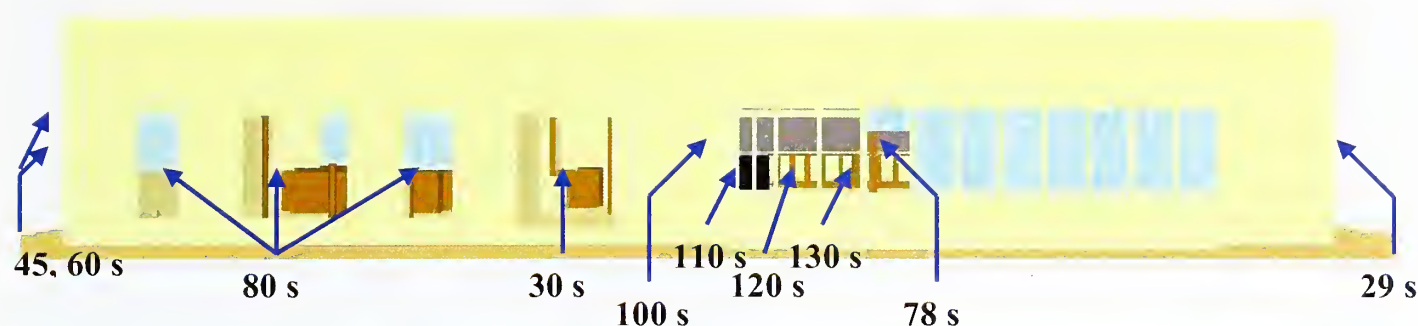
At 78 seconds, the lower portion of one of the bay windows was removed. This appeared to occur as the cameraman passes by on his way to the rear of the structure. Portions of the windows located on the front of the structure, left of the main entrance were removed at 80 seconds. This included the lower half of each of the matching windows next to the large window in the center, the entire large window in the center, all of the thin window to its left and the lower half of the thin window to its right. Finally, more sections of the bay window, surrounding the portion that was removed at 78 seconds, were removed between 100 and 130 seconds. The side bay window facing the main entrance was seen open in the WPRI video and the three other windows between the side window and the lower portion of the window were removed at 78 seconds based on the sounds heard in the video. Vent opening times are summarized in Table 5-6 and visualized in Figure 5-41.

Figure 5-41. Visualization of Opening Times

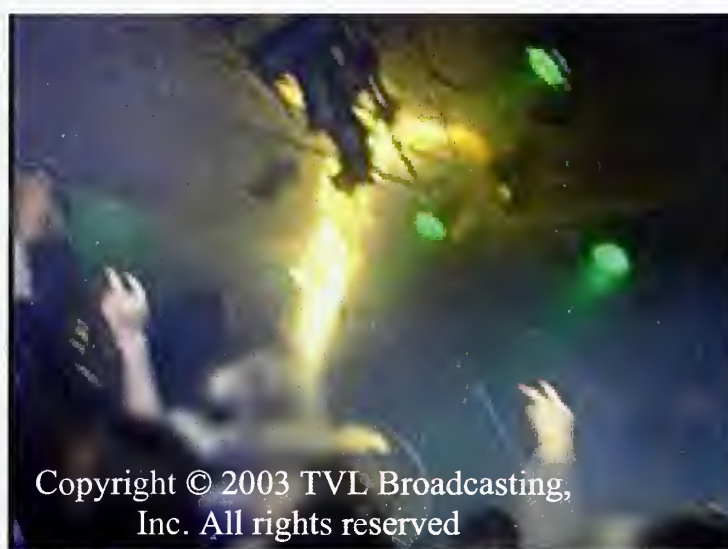
The images from the video in Figures 5-43 and 5-44 capture the initial state of the fires on each side of the platform shortly after the gerb discharge had stopped. At 10 seconds after ignition, the fire can be seen burning on two surfaces at each of the corners; this is also considered in the simulation with the placement of the ignition vents on both sides of the corner. In both the simulation and the actual incident the flames impinge on the ceiling within 20 seconds after ignition.

Figure 5-44. Flames impinging on ceiling (19 seconds)

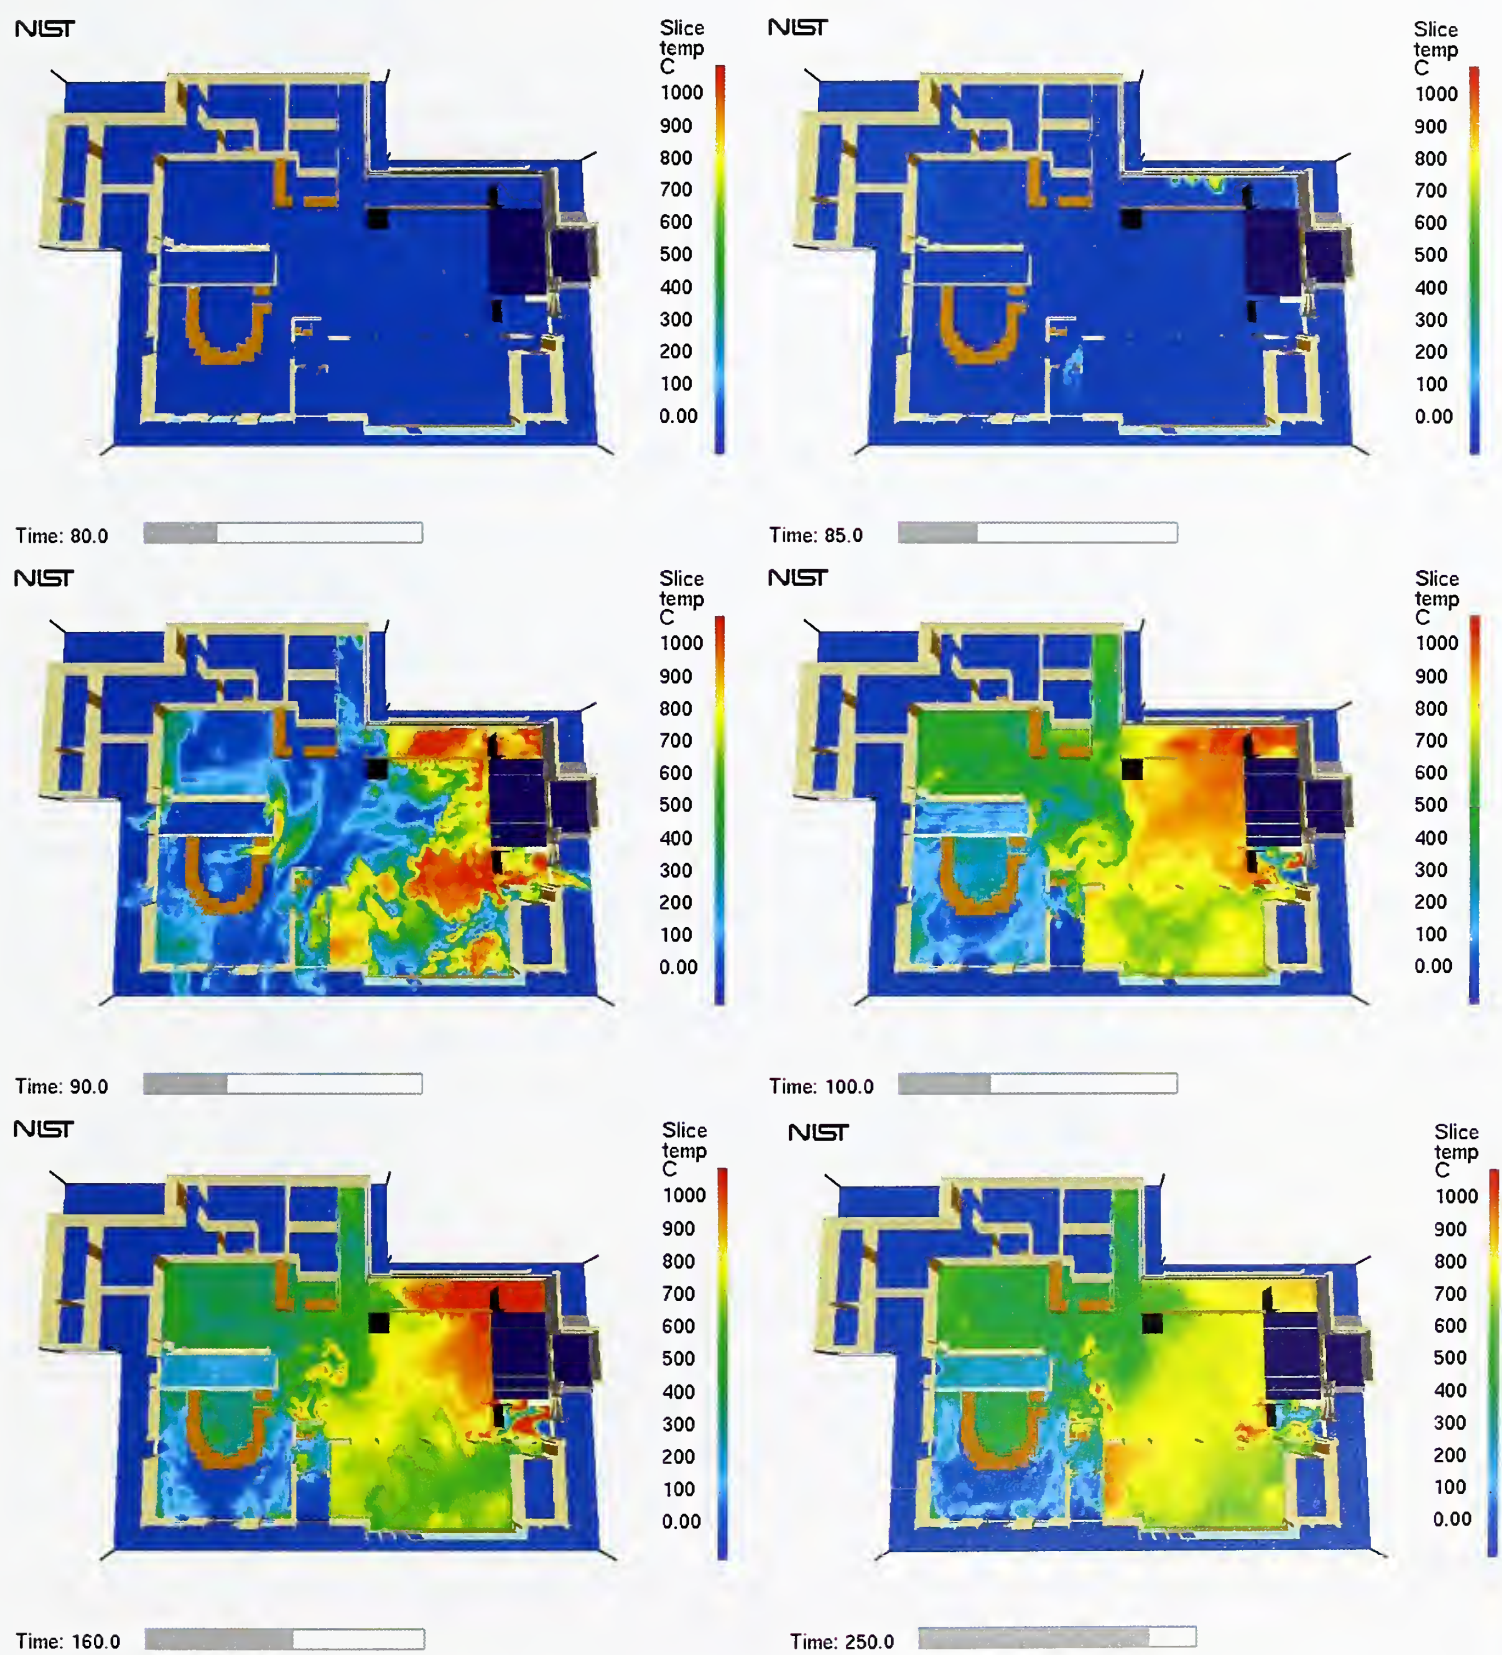
Figure 5-56. Temperatures at 0.6 m (2 ft) above the floor, 80 seconds to 250 seconds

At the 0.6 m (2 ft) height above the floor conditions remain tenable for a longer period of time than at the higher elevation. Figure 5-56 contains images captured at the same time intervals as in the previous figure. One can see that the dance floor and adjacent areas reach untenable temperatures in the simulation within 90 seconds after ignition. The sunroom and dart room areas are predicted to reach untenable temperatures within another 10 seconds.

The significant differences in temperature between the 1.5 m (5 ft) elevation and 0.6 m (2 ft) occur in the main bar room and the main entrance. This area remains tenable at the lower level due to the inflow of fresh air through the open windows and open doorways. The cooler temperatures toward the floor at both the front door and main bar area explain why occupants were seen in the WPRI video escaping from the windows and doorway later into incident. The temperatures in later images do not change significantly regarding areas that have untenable conditions versus areas that remain tenable based on temperature only.

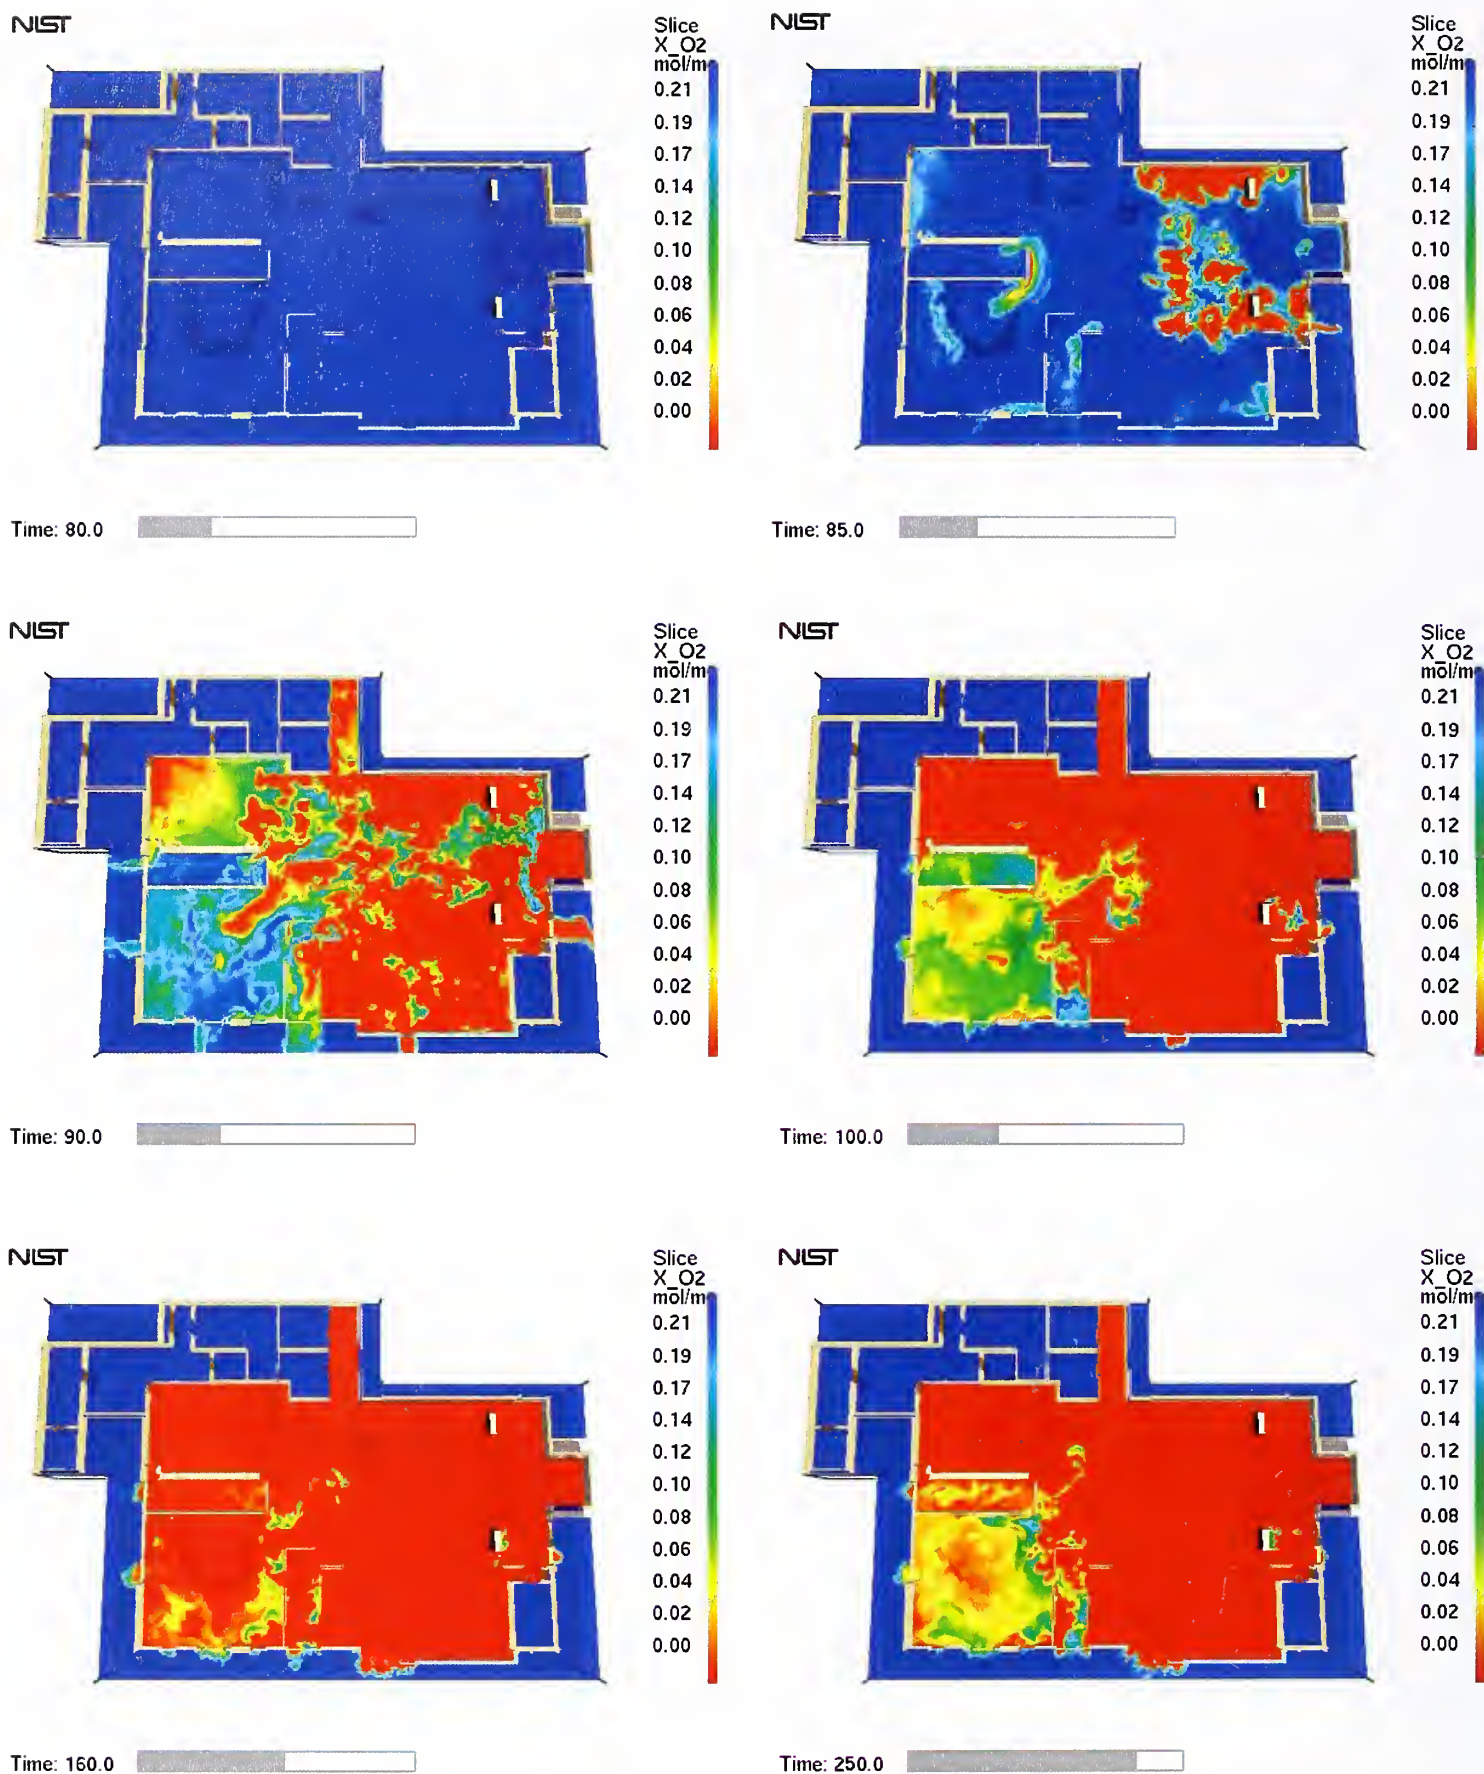
Figure 5-61. Oxygen volume fractions at 1.5 m (5 ft) above the floor, 80 seconds to 250 seconds

Just as the temperature levels rose rapidly after the platform area became fully involved in flames, the oxygen levels drop proportionally. As shown by the three dimensional smoke output in the previous section, the smoke spreads quickly through the structure. The first four images in Figure 5-61 range from 80 seconds after ignition to 100 seconds after ignition. This sequence has the most dramatic changes in oxygen concentration. Beyond 100 seconds the entire structure is untenable at the 1.5 m (5 ft) height. Tenability exists for the longest duration in the main bar area. Most of the building, including the platform and dance floor areas, the dart room, the main entry foyer and the main bar room, is shown by the simulation to be significantly depleted of oxygen to less than two percent.
